State of the excavation works of the 15th century shipwreck in Urbietta (Gernika, Spain)

During the works run by the Town Hall and the Coastal Demarcation Board for repairing and canalising the estuary of Gernika, remains of a clinker built vessel were found in late July 1998. The shipwreck is 10 to 12 metres long, dating 1460, according to C14 analysis.

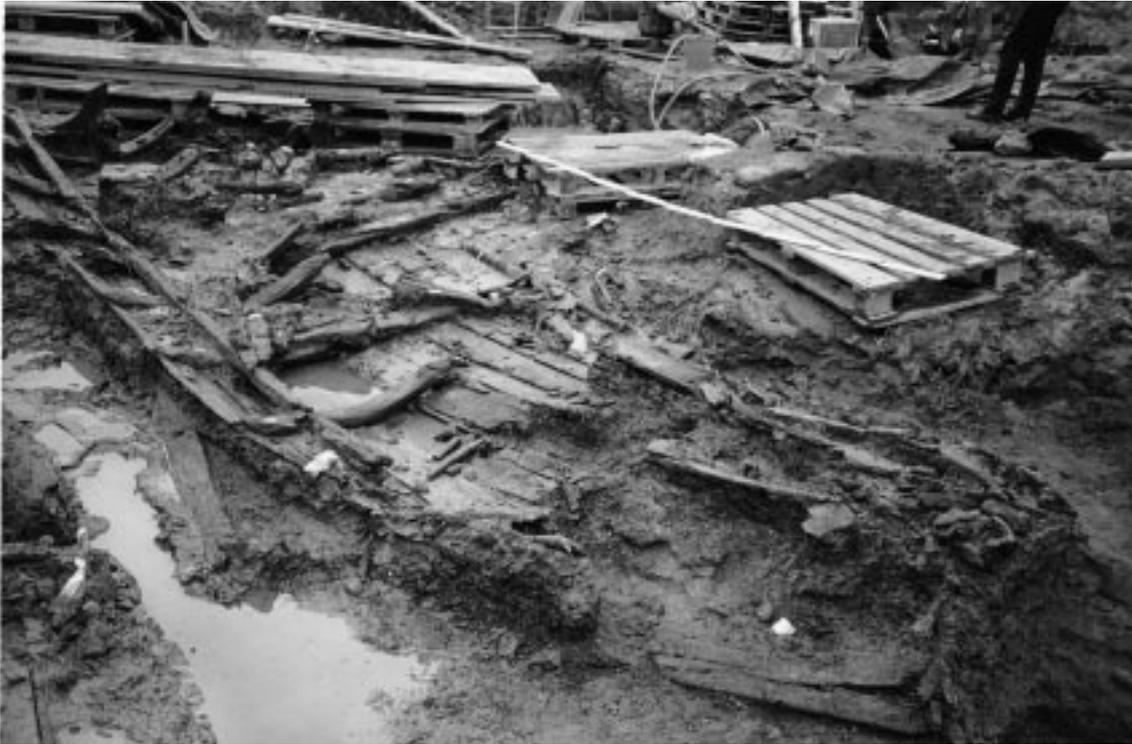
FIG. 1 – General view of the shipwreck during its excavation.

The Urbieta shipwreck is a small clinker vessel. Her remains are spread in an area of around 12 x 5 metres. Her stern keeps a direction of 10° E, which places the vessel in the same direction as the river current and aground in its left bank. This position made the vessel be broken in such a way that what remains today is her port side spread along the riverbed on an almost

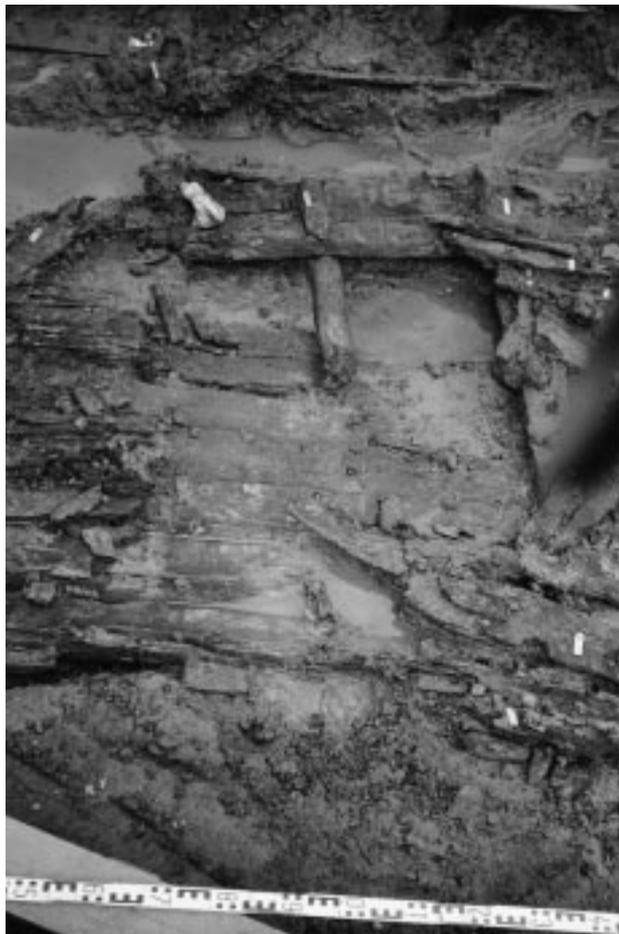
FIG. 2 – Detail of the hull's inner part.

horizontal situation. Thus, the keel and parallel to it all the planks up to the port side gunwale are disposed completely horizontal. In zone near the sternpost a part of the starboard side of the hull is in the inner part of the vessel that belongs to her port side; therefore, this part of the hull shows her outer side whereas the rest of the hull is her inner side.
